Ashtabula Breakwater Common Tern (*Sterna Hirundo*) Nesting

By Thomas J. Fredette, Richard J. Ruby, Paul Bijhouwer,
Burton C. Suedel, Michael Guilfoyle, Marleen Kromer,
and Karen Adair

PURPOSE: This document summarizes the design features used to create a nesting area for the Common Tern (*Sterna hirundo*) that was incorporated as part of the maintenance repairs to the harbor breakwater located in Ashtabula, OH. The purpose of the tern nesting project was to demonstrate an option that can be used during such maintenance activities for increasing infrastructure benefits as part of the Engineering With Nature initiative (Bridges 2012). The U.S. Environmental Protection Agency's Great Lakes Restoration Initiative (GLRI) and the U.S. Army Corps of Engineers' Dredging Operations and Environmental Research (DOER) Program sponsored the development of the nesting habitat site. The project was developed in consultation with the The Nature Conservancy and the Ohio Department of Natural Resources.

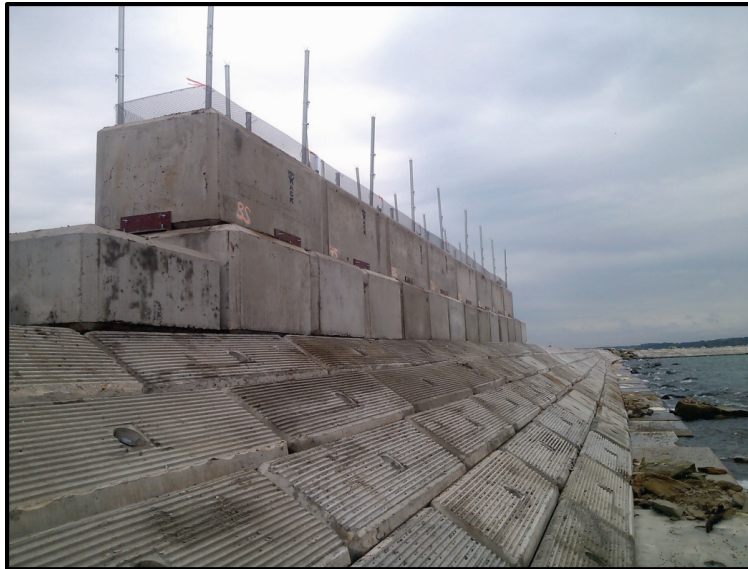
Figure 2. Nesting habitat blocks installed on the Ashtabula breakwater. Toe blocks are at the far right of the breakwater at water level.

Block Design. The repair material used at Ashtabula consisted of pre-cast concrete blocks. Large 8' x 8' x 4' blocks were used to form the base or toe of the structure, and smaller angled blocks were used to create the side slope with cap blocks at the crest (Figures 2 & 3). A Tern habitat was designed using modified toe blocks that were cast with a 6" deep recess in the top that could be filled with gravel suitable for a nesting habitat (Figure 3). Several drain holes, created by casting 3/4" ID PVC pipe into the blocks, were included so that water from rain and waves would not accumulate in the recesses. The recess was also set in from the edges of the blocks so that the lip would be unlikely to experience breaks during installation or as a result of environmental elements. In addition, in each corner of the recesses, a 2 3/8" ID, 1' long section of Schedule 40 PVC pipe was cast into the blocks. The PVC pipe was installed to create sleeves that could accommodate galvanized steel posts that were part of the avian competitor/predator exclusion measures that were also part of the habitat design (discussed below). A listing of materials and equipment used to construct the block nest habitat is shown in Table 1.

Structural Design. The nesting habitat feature consisted of a double row of stacked 8' x 8' x 4' blocks. The first row was placed perpendicular to the breakwater crest, and the top row, the nesting blocks, were placed end-to-end, parallel to the breakwater alignment (Figure 2).

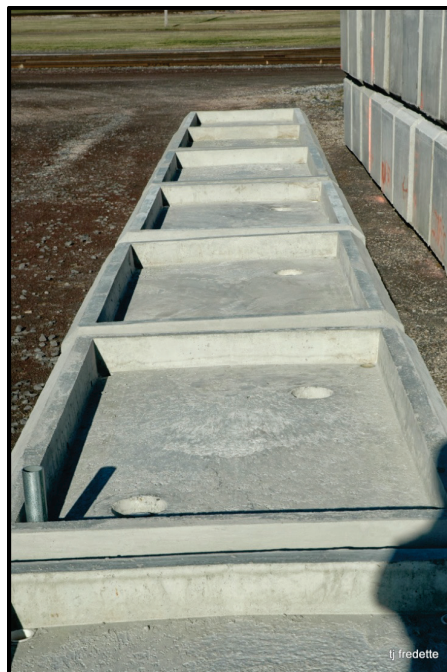
Figure 3. Modified toe blocks used for the tern habitat with top recess for nesting gravel.

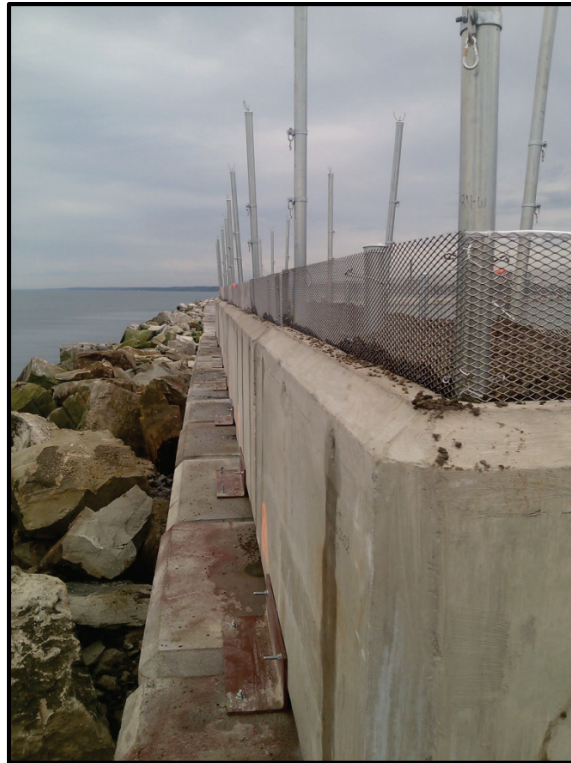
Figure 4. Angle iron cleats installed at the base of the habitat blocks to increase structural stability.

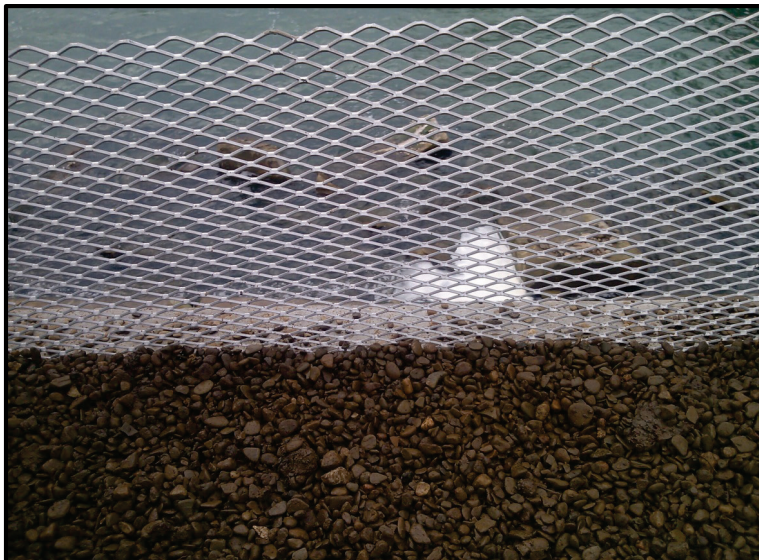
Figure 5. Pea gravel and stainless steel mesh fencing installed on the nesting habitat blocks.

Nesting Area Design. The Phase 1 nesting site consisted of eight, 8-foot long blocks placed end-to-end for approximately 250 ft² of nesting area. The recesses in the blocks were filled with pea gravel of a size (¼" to ½" size stone) utilized by Common Terns as nest sites (Figure 5). The nesting area was protected by a predator exclusion system, which consisted of side fencing, two sets of side cables, and an overhead grid of cables (Figure 6). The spacing in the overhead cables (about 1.5' x 2') was designed such that the relatively acrobatic and smaller Common Terns could access the site, but larger and less agile birds such as cormorants, gulls, and owls would be excluded. Gulls and owls are potential predators on eggs and chicks, and cormorants are a potential competitor for the space on the nest block habitat. The predator exclusion cables were attached to 6.5' long galvanized fence posts that were inserted into the PVC sleeves then cast into the concrete blocks. Posts were installed prior to filling the blocks with gravel. The cabling was cut and assembled while the blocks were set up shoreside prior to installation on the breakwater (Figure 6). Cables were attached to the posts using brackets, links, and carabineers (Figure 7). Longitudinal cable sections were made to reach the length of two blocks (16'), and the cross pieces

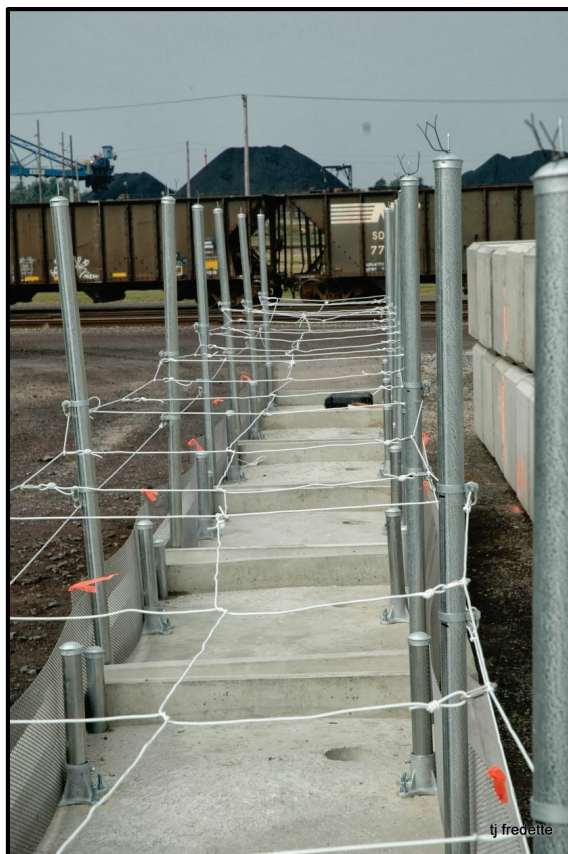
Figure 6. Predator/competitor exclusion cables. Cabling was measured, cut, and installed when the habitat blocks were still onshore. Once the installation was completed, the cable was removed for winter storage and subsequently reinstalled in spring.

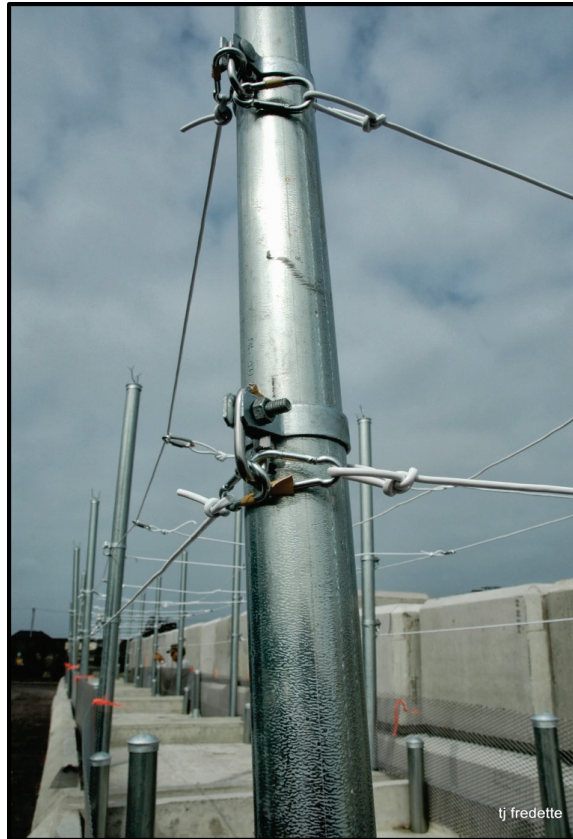
Figure 7. Carabineers and links used to attach the cabling for easy assembly and disassembly.

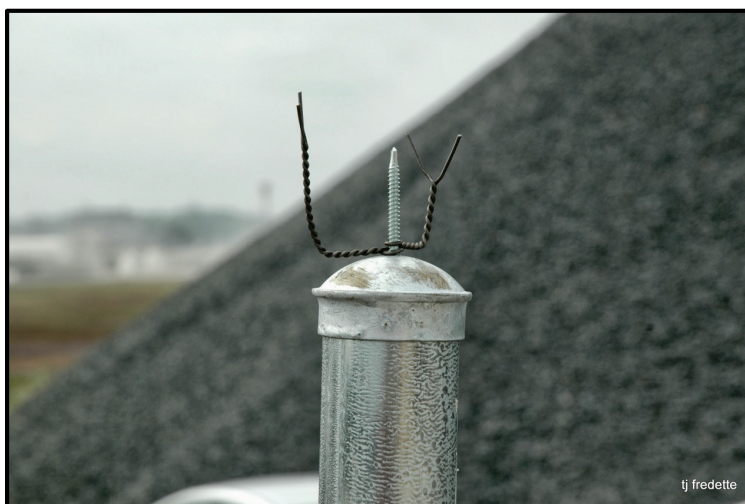
Figure 8. Gull roosting deterrent spikes on fence post caps.

were all individual pieces. The cable was a coated 5/16" PVC clothesline. Posts were topped by a galvanized cap. The cap had a long screw installed with the tip pointing upward. The screw was attached to two pieces of twisted wire for deterring roosting by gulls (Figure 8). The side fencing was 1/2" expanded stainless steel mesh cut in 16" wide sections. In addition to keeping predators from accessing nests, the fencing was also intended to keep tern chicks from falling over the edge.

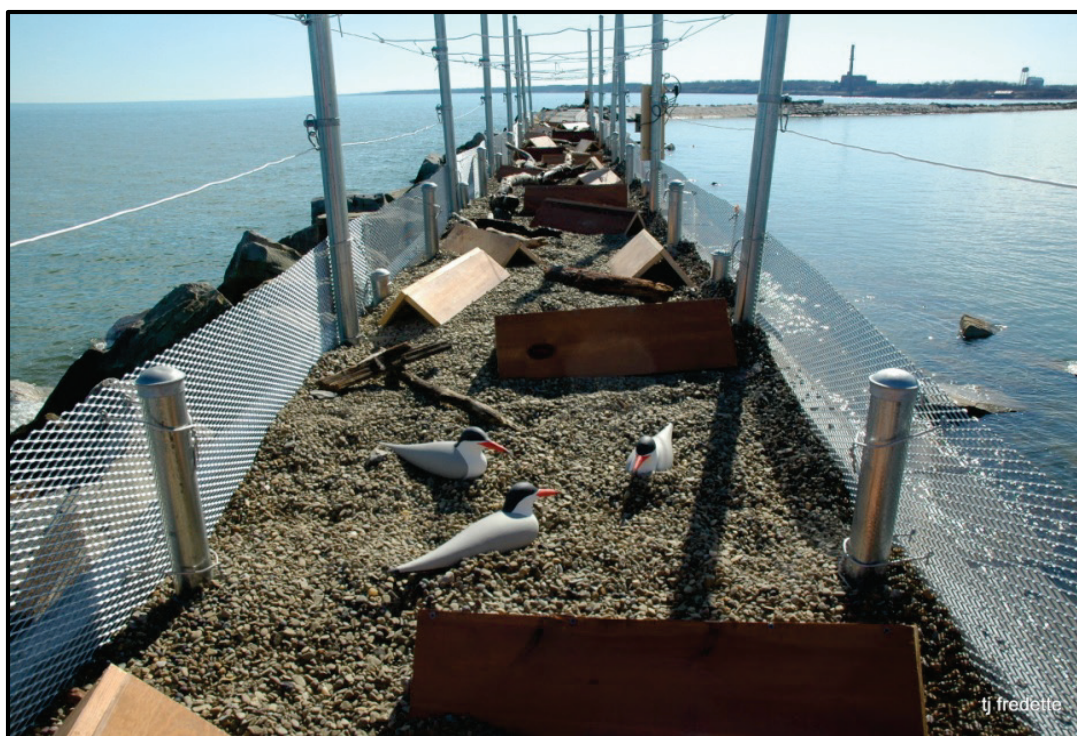
Figure 9. Tern decoys used to attract passing terns and chick shelters installed at the site.

Tern decoys purchased from Mad River Decoy, Waitsfield, VT were made of hollow, rotomolded polyethylene material, filled with sand, and sealed with duct tape in order to keep strong winds from moving them. Six decoys were installed in two groups on the ends of the habitat area (Figure 9). The solar powered call box pictured in Figure 10 was purchased from Murremaid Music Boxes, Bremen, ME. Three infrared, motion sensitive SpyPoint cameras and power cables were purchased from GG Telecom, Victoriaville, QC, Canada and connected to the solar panel system to help document activities at the site. Volunteers coordinated by The Nature Conservancy made chick shelters using salvaged materials. Eight shelters were installed at the site in Phase 1. Driftwood was also randomly placed in the nest area to provide additional shelter and site complexity desired for nest site selection by terns (Figure 9).

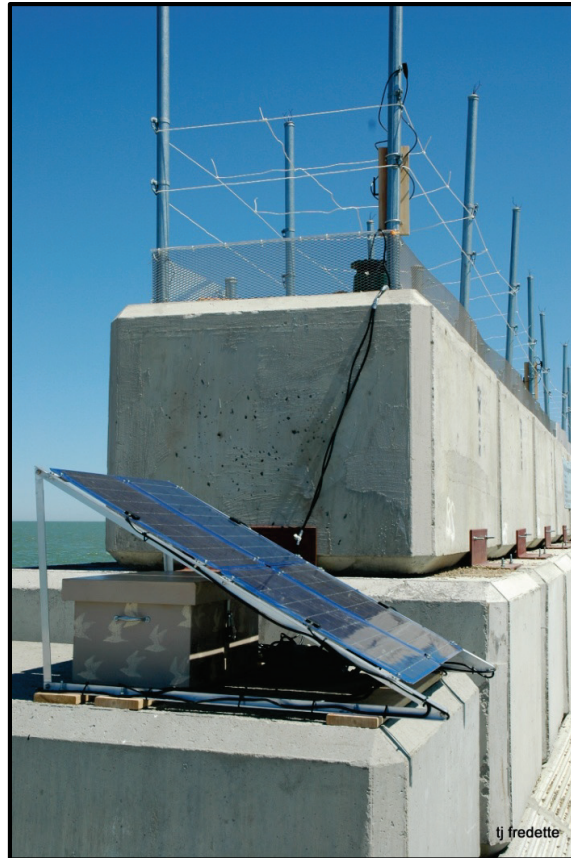
Figure 10. Solar powered tern-call system installed on the breakwater. Cables from the system power drum-shaped speakers located on each end of the habitat area.
